Missouri School Seismic Safety Initiative

N. Gould¹, M. Griffin², P. Gould³

MO Seismic Safety Commission (MSSC)
School Earthquake Safety Initiative

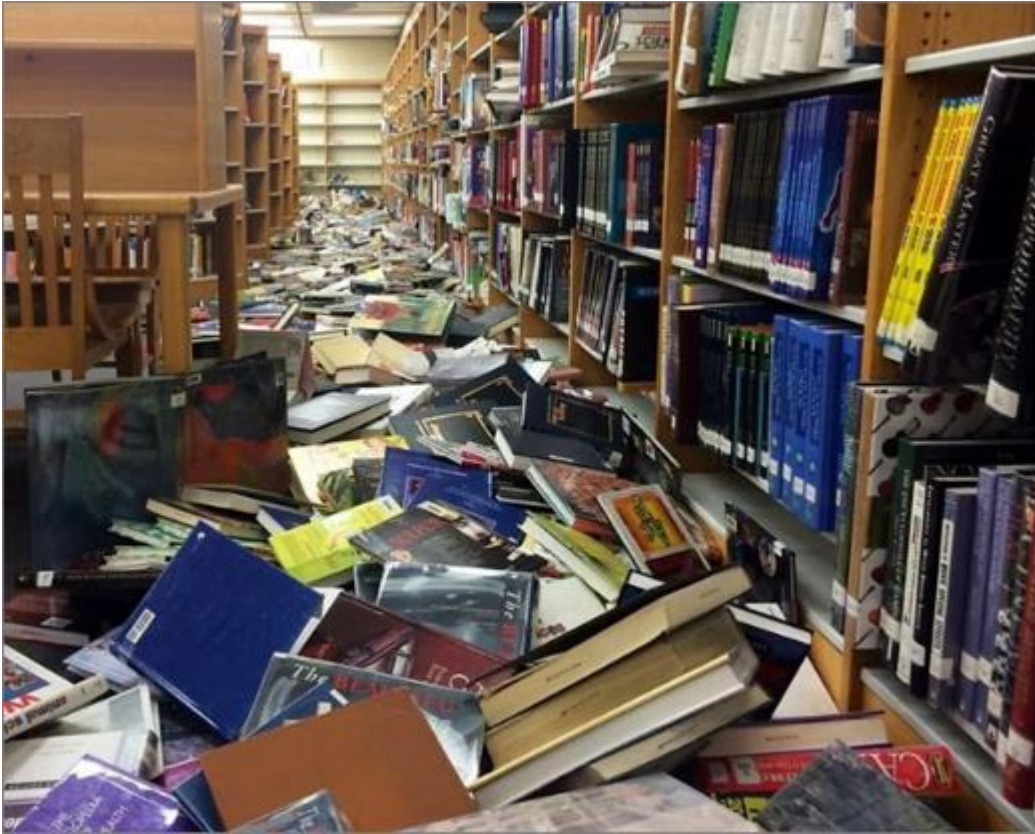
South Napa California EQ

Nonstructural Components

Photo by Will Kane, Politico Magazine
South Napa Earthquake, Aug. 2014 (M6.0)

Nonstructural content damage (dislodged light fixtures, toppled shelving, cracked wall coverings, damaged furniture, broken windows)

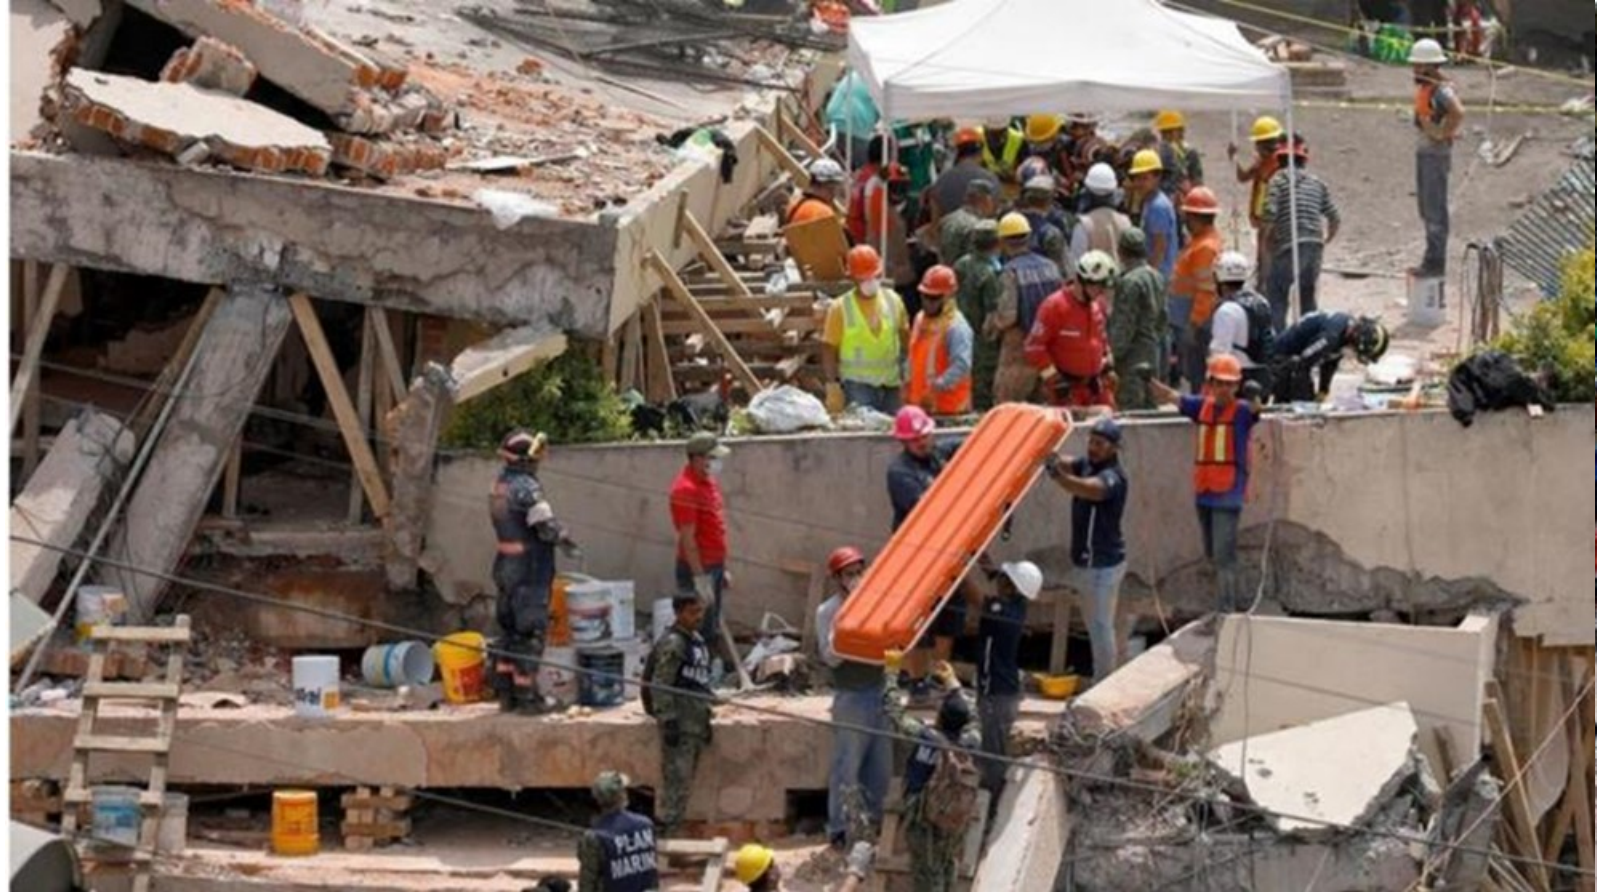
2017 Mexico City Earthquake

- At least 21 children and four adults died at the Enrique Rébsamen School.

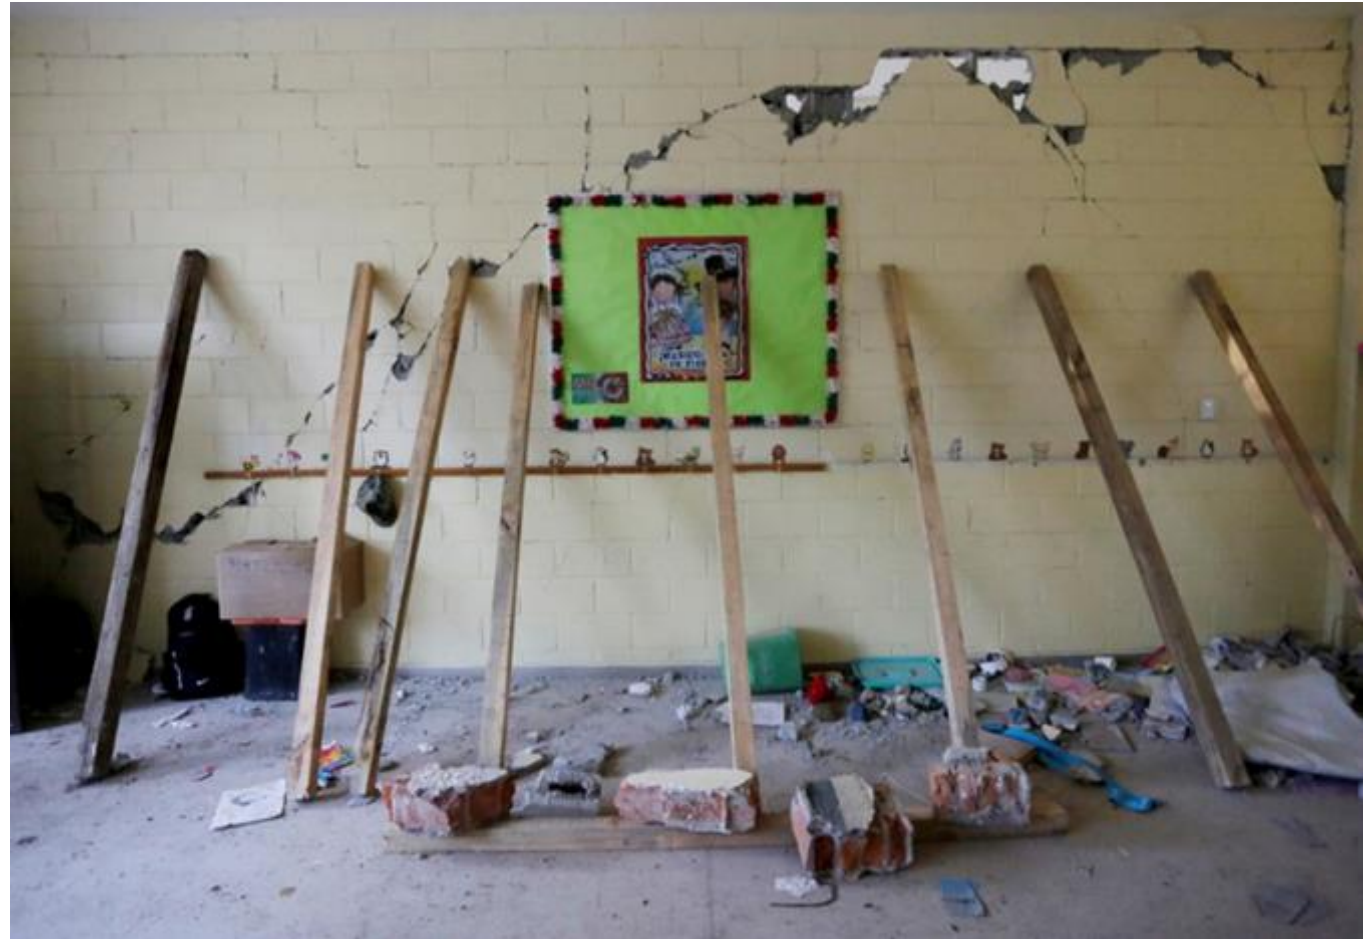
2017 Mexico City Earthquake

- Enrique Rébsamen School – Partition wall shored after the EQ

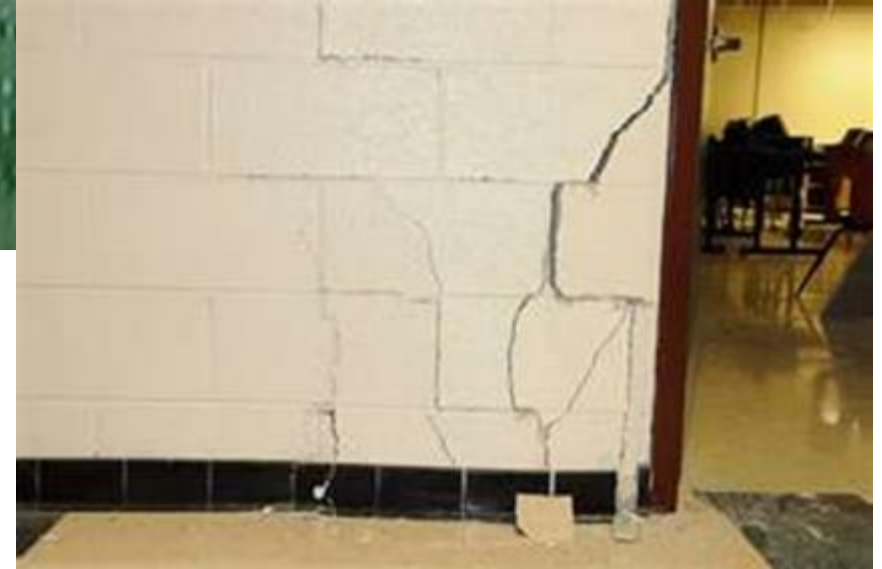
Mineral, VA Earthquake M5.8

- Small magnitude event
- Region of infrequent activity for moderate and large events
- No fatalities
- 6 schools – 2 total loss (Elem & High School)
- 40% of classroom space lost
- Estimated losses \$200 - \$300 million
- Extensive nonstructural damage to the new Louisa County High School

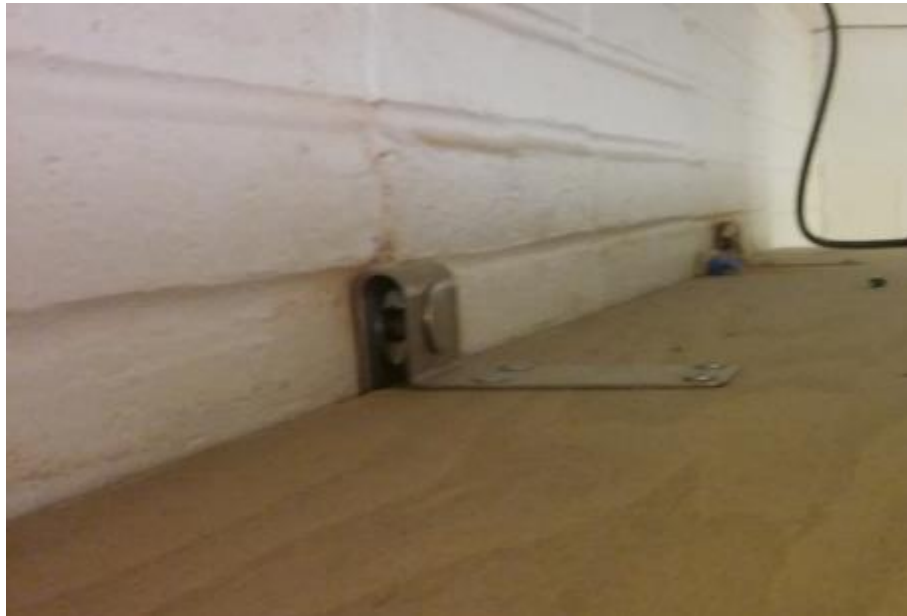
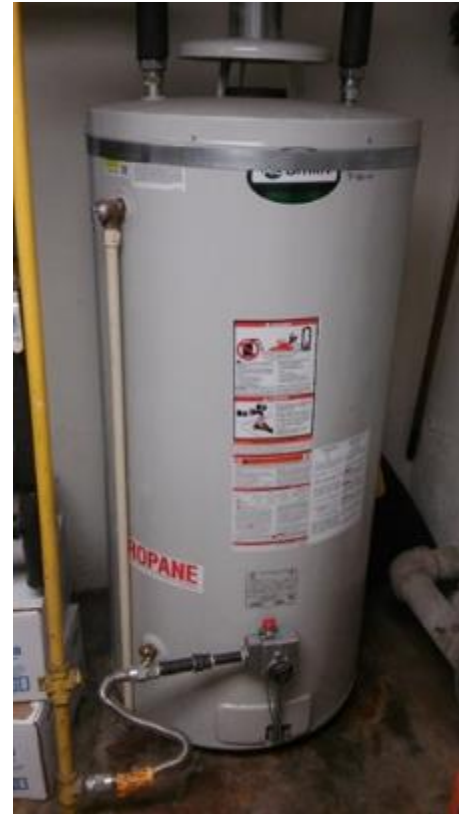
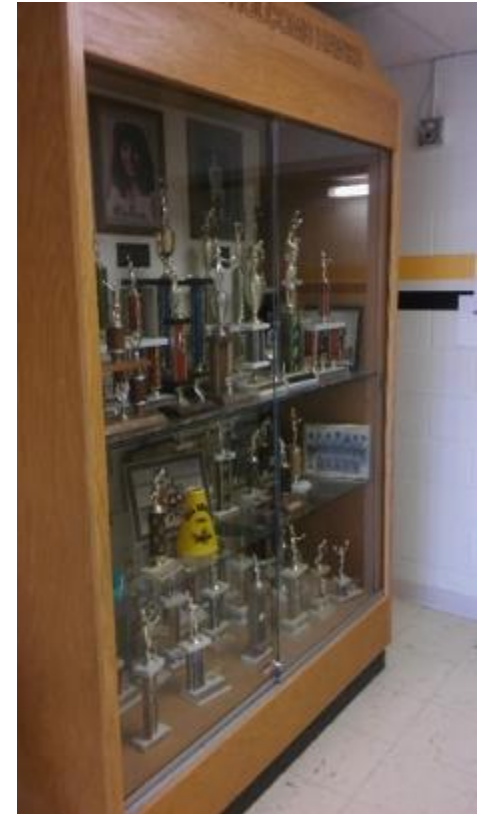
Nell Holcomb R-IV School District *challenge to achieve*

Nonstructural components & systems seismic safety improvements implemented from MO SEMA 2012 Small Grant Program:
